Insert Wear Reference Guide

Common Types of Insert Wear in Metal Machining with Indexable Carbide

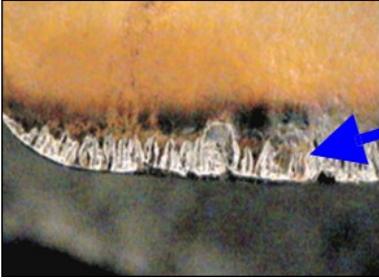
Thermal Cracking

Thermal cracking shows up as small cracks perpendicular to the cutting edge, resulting in chipping and poor surface finish.

- Excessive variations in surface temperature, intermittent machining, or variations in coolant supply

- Select a tougher insert grade
- Eliminate the use of coolant whenever possible

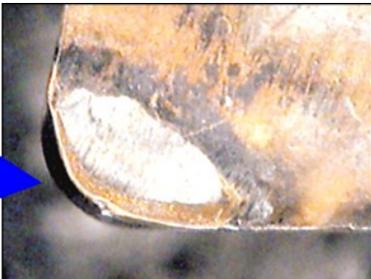
Plastic Deformation

Plastic deformation of the cutting edge is characterized by a depression of the edge, or an impression on the insert flank, leading to a poor chip control, poor surface finish and insert breakage.

- Too high of a cutting temperature

- Select a harder, more wear resistant grade
- Reduce the cutting speed
- Reduce the feed rate

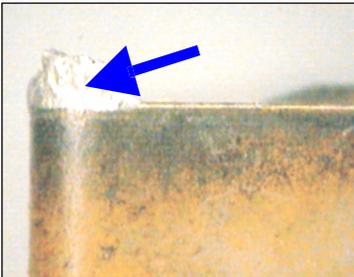
Built-Up Edge

Built-up edge on an insert will cause poor surface finish and chipping cutting edge when the BUE is torn away.

- Cutting zone temperature is too low
- Negative cutting geometry
- Machining of very sticky materials such as low-carbon steel, stainless steels and aluminum

- Increase the cutting speed
- Change to a more suitable coated carbide grade
- Select an insert with a more positive geometry

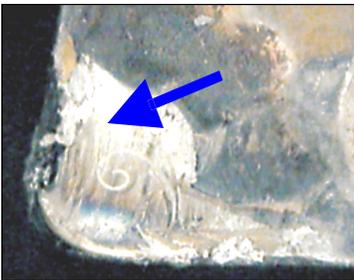
Crater Wear

Excessive crater wear causes a weakened cutting edge and poor surface finish quality.

- Excessive cutting temperatures and pressures on top of the insert

- Reduce cutting speed or reduce feed rate to lower the temperature
- Select a more wear resistant carbide grade
- Select a positive insert geometry

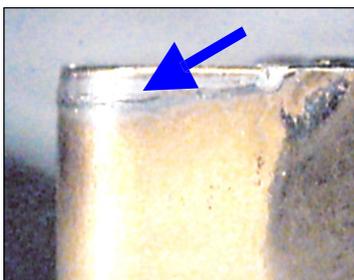
Flank Wear

Flank wear is the preferred type of insert wear, symbolizing a normal insert wear over time. Rapid flank wear however can cause poor surface finish quality or an inconsistency in tolerances.

- Cutting speed is too high, or the chosen carbide grade does not offer sufficient wear resistance

- Select a more wear resistant grade
- For work-hardening materials, select a smaller entry angle
- Reduce cutting speed when machining heat resistant materials
